1 Qualitative assessment of demoulding

1.1 Industrial mould

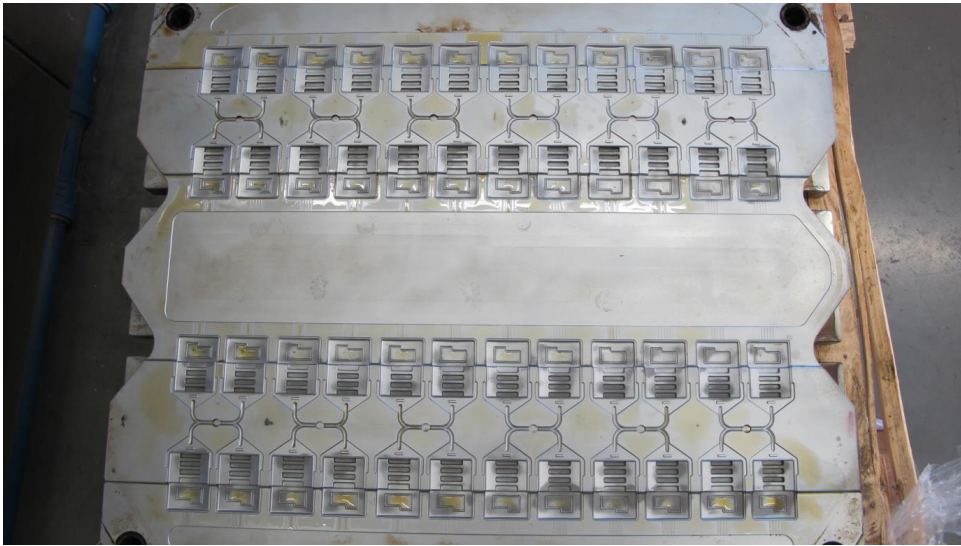
Figure 1. Production mould for demoulding assessment property of BARBIERI – Mould GBS5852-300-500-96A

The SME BARBIERI has performed the qualitative assessment of demoulding of a production mould of its property, without and with a PVD coating, which was applied by the SME DMX. The production mould used for this exercise is shown in **Figure 1**.

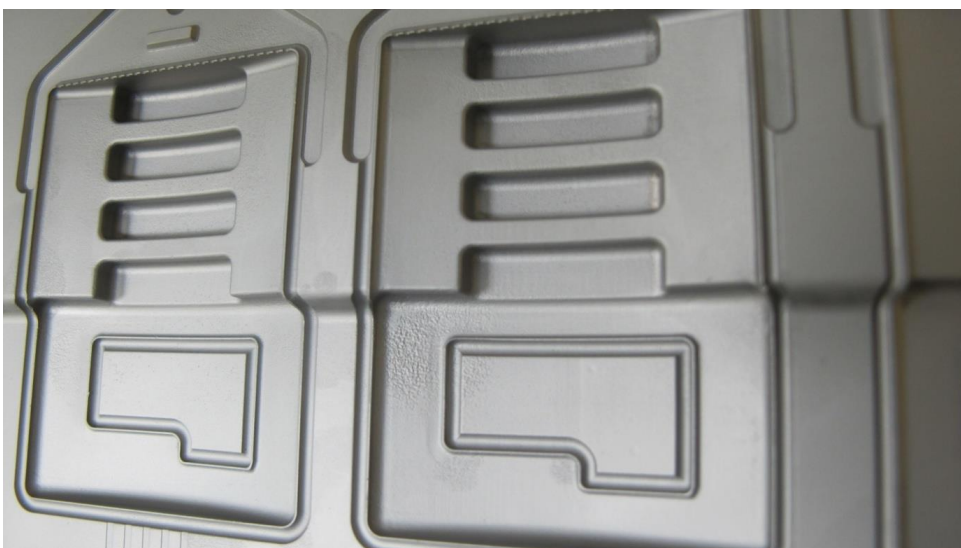
Figure 2. Detail of the repaired surface of the mould by DMX

Initially, the mould selected by BARBIERI was severely damaged by an intensive service and it seemed that the substrate had been attacked by acids at some point of its life. DMX stripped the mould, prepared the surfaces by micro blasting with very fine media (F500), process that was not able to repair the smallest damaged portions and degas the cavities before proceeding with the PVD coating. **Figure 2** shows the result of this reparation process on the surfaces of the mould.
